Manhole Inspection Summary

Manhole # S07YY_001MH

Insp Date: **7/16/07 11:59 AM**

Location Address: **INTERSECTION EDGERTON** Cross Street: **CALLAWAY AVE**

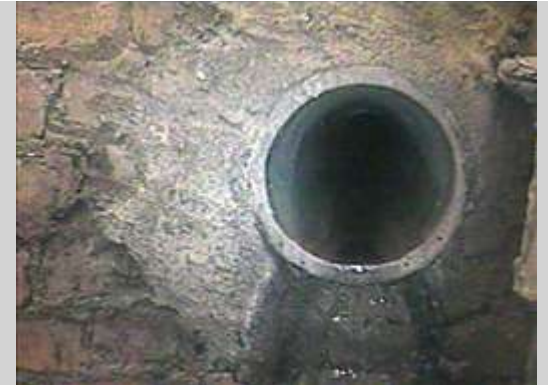
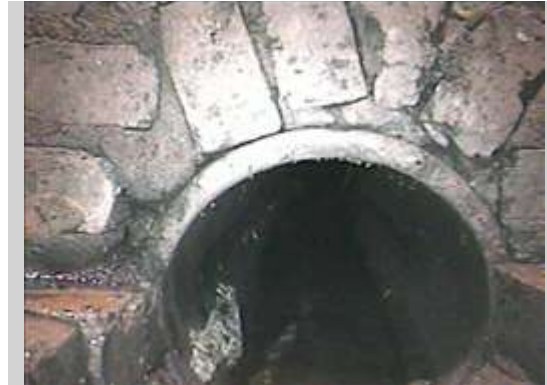
12 O'Clock Outflow

Pipe Out @ 12 O'Clock

Pipe Material: **Clay** ☐ Pipe Lined

Invert Depth: **10.70** (ft.) Flow Characteristics: **Slow**

Infiltration: **None** Pipe Seal Cond: **Sound**

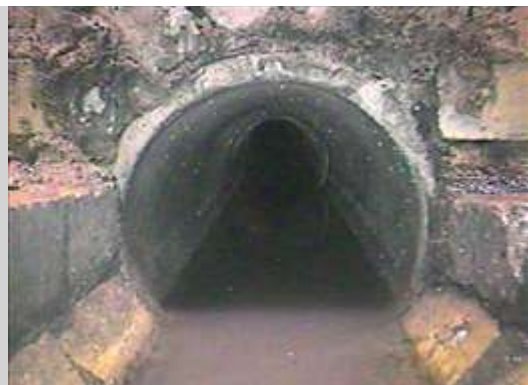
6 O'Clock Inflow

8 in. Circular Gravity Sewer
Pipe In @ 6 O'Clock

Pipe Material: **Clay** ☐ Pipe Lined

Infiltration: **None** Pipe Seal Cond: **Sound**
